NIST NCSTAR 1-5A

**Federal Building and Fire Safety Investigation of
the World Trade Center Disaster**

Visual Evidence, Damage Estimates, And Timeline Analysis

William M. Pitts
Kathryn M. Butler
Valentine Junker

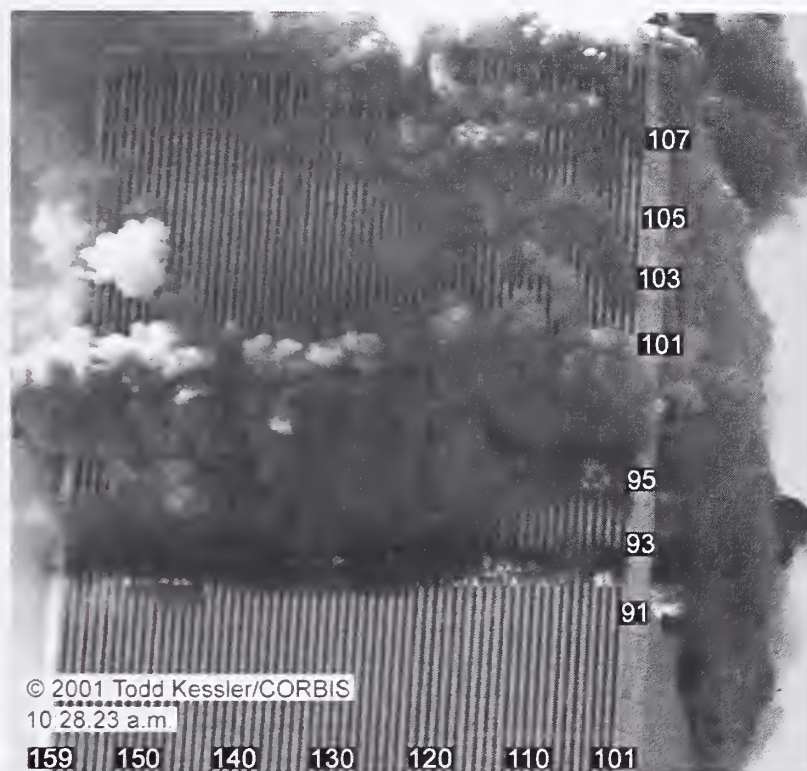
The photograph shown in Figure 8–101 was shot 1.4 s after WTC 1 began to collapse. The lines of dust visible coming from the 98th floor on the north and west faces of the tower may be an indication that the collapse began near this floor. As the building collapsed it acted as a piston, forcing air downward onto other floors. The resulting pressure increase forced gas flows out of open windows on lower floors. As a result of this process, fire and smoke were pushed out of the building.

Figure 8-101. This cropped photograph shows the north face of WTC 1 at 10:28:23 a.m. The image has been enhanced by adjusting the intensity levels. Column and floor numbers have been added.

In the photograph a large area of fire is being pushed from windows on the 92nd floor on the west side of the north face and the north side of the west face. This is the region where an intense fire had grown during the previous ten minutes or so. Fire is evident coming from windows across the large room on this floor with walls at columns 92-105 and 92-132 (see Figure B-1), as well as from the room in the northwest corner with internal walls at columns 92-455 and 92-105. The large volume of fire being pushed out of the windows provides an indication of how widespread the flames were in this area of the tower. Smaller flames are also visible coming from windows 92-146 to 92-152 on the eastern side of the

face. This indicates that fires had continued to burn in two of the small rooms located along the north face (see Figure B-1).

Flames were also pushed out of windows located in the northwest corner room on the 95th floor with walls at columns 95-108 and 95-456 (see Figure B-4). This is an area that had been burning earlier, but had appeared to have died down just prior to the initiation of the collapse. It is clear from this photograph that a significant fire was still burning in the immediate vicinity. The absence of visible fire being expelled elsewhere on the north face provides additional evidence that intense fires observed at other locations on the north face at earlier times had either died down or gone out.

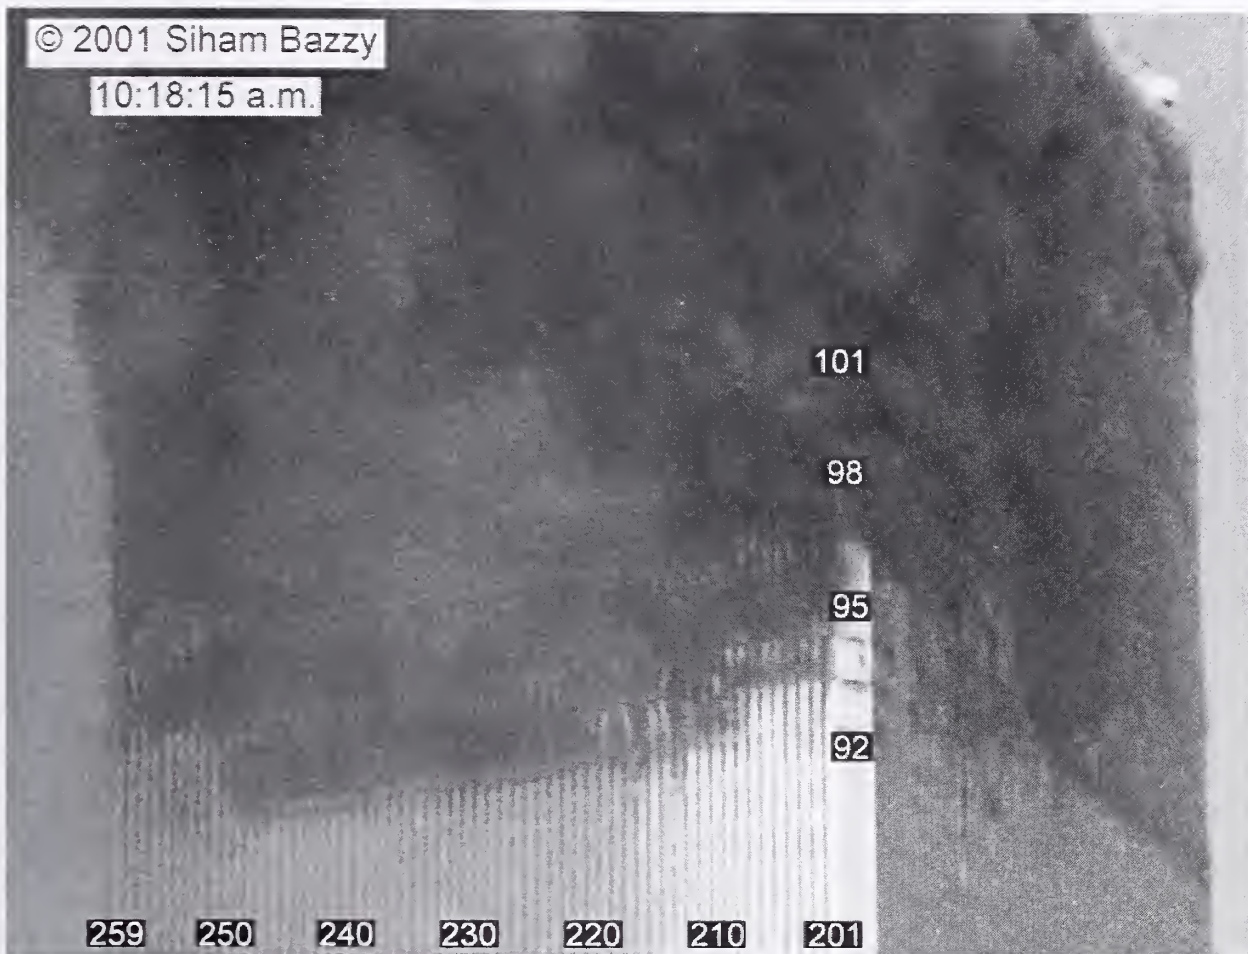
Figure 8-102 shows a view of the east face of WTC 1 recorded at 10:18:15 a.m. The face is still partially obscured by dust rising from below. The fire distribution is similar to that derived from the partial view of the east face shown in Figure 8-86 at 10:17:33 a.m. The largest fire is on the 98th floor and extends from roughly window 98-210 to window 98-228. There still appears to be some flame extension from open windows, but the large flames evident in Figure 8-86 are not present. Flames fill several adjacent windows on the 97th floor centered near window 97-244. Flames are also present on the 96th floor, but do not appear as intense as those seen on the 97th floor. There is definitely a fire burning higher up on the 101st floor near window 101-225. Recall that this fire was also visible in Figure 8-86, but that its presence could not be definitely confirmed due to the intense fire burning lower down on the 98th floor.

Figure 8-102. This cropped photograph showing the east and north faces of WTC 1 was shot at 10:18:15 a.m. It has been enhanced by adjusting the intensity levels. Column and floor numbers have been added.

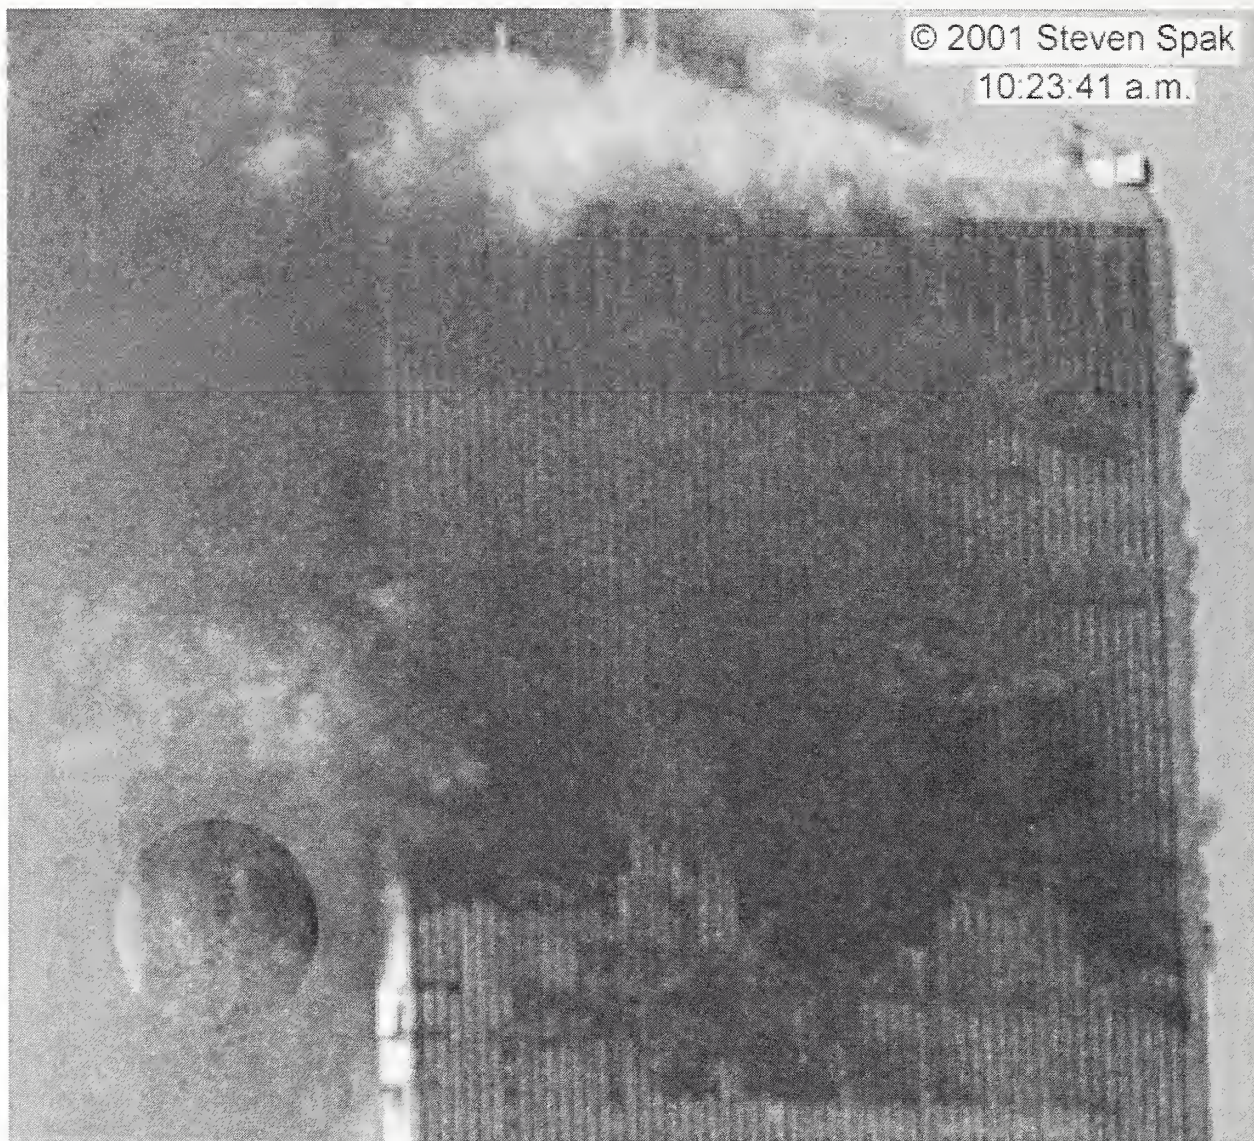
This area of flame on the southern side of the east face is visible in Figure 8-99, which was taken at 10:23:30 a.m. The fire is burning intensely with extended flames. Figure 8-103 shows a lower-resolution photograph taken at 10:23:41 a.m. that provides a slightly less oblique view of the east face in which it is easier to identify the flame location. The area where flames are visible coming from open windows has been highlighted. Flames can be seen on the 98th floor at two apparently separated locations. One of these is near the center of the face, and the second is well to the south. Even though the flames appear to be separated, videos and Figure 8-99 show that the flaming region was continuous over this length. A small area of fire is also visible on a lower floor. This fire is most likely on the 97th floor near the location where fire was present (near window 97-145) in Figure 8-102 at 10:18:15 a.m.

Figure 8-103. This cropped photograph shows the north face and an oblique view of the east face of WTC 1 at 10:23:41 a.m. The intensity levels in an area of the east face have been adjusted to highlight an area of extended flame.

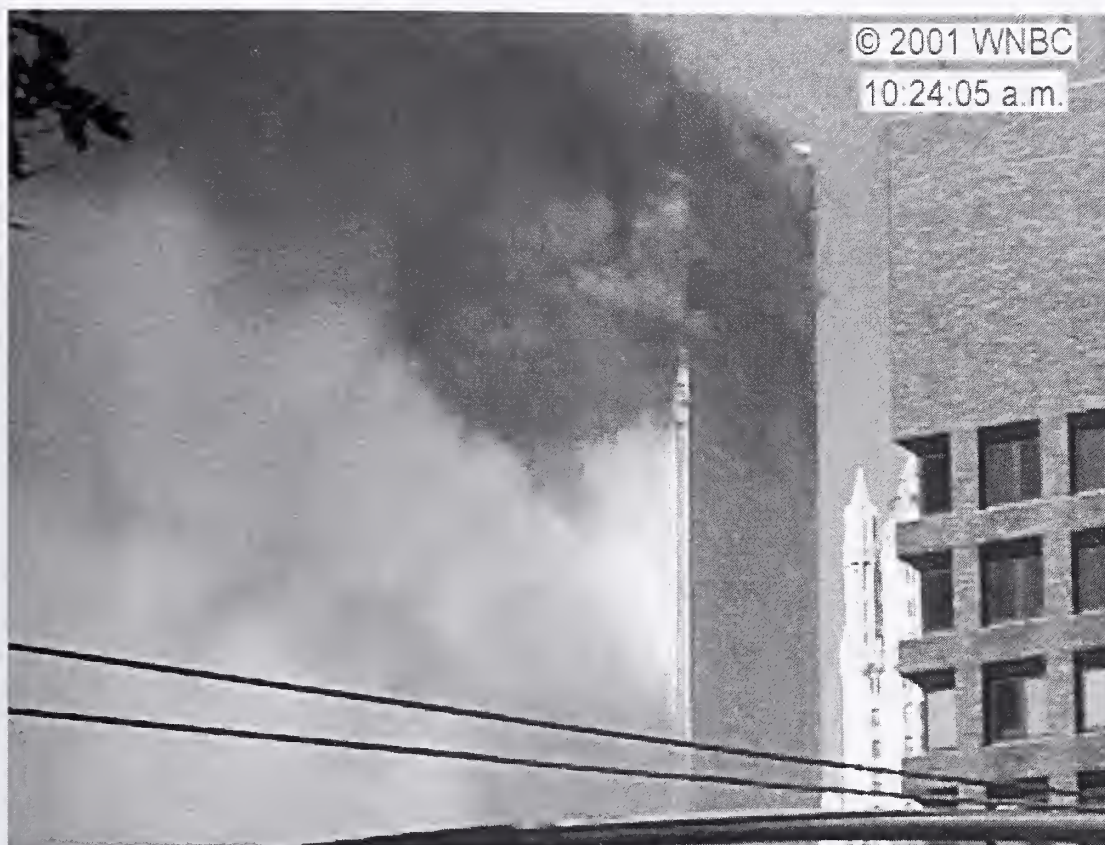
An image of the east face shown in Figure 8-104 taken from a video recorded at 10:24:05 a.m. provides another view of the fire burning on the south side of the 98th floor east face. Since this image was recorded from further east than Figure 8-103, it is easier to identify the location of the burning area. It does extend from near the center of the face toward the south. An area of fire on the 97th floor is visible immediately below. At 10:18:15 a.m. a similar area of fire was visible near window 97-245 (see Figure 8-102). This location is consistent with the apparent position of the fire in Figure 8-104. This suggests the intense fire present on the 98th floor roughly covers windows 98-230 to 98-245.

Figure 8-104. This frame was taken from a video recorded at 10:24:05 a.m. It was shot from the northeast and shows the north and east faces of WTC 1. The image has been enhanced by adjusting the intensity levels.

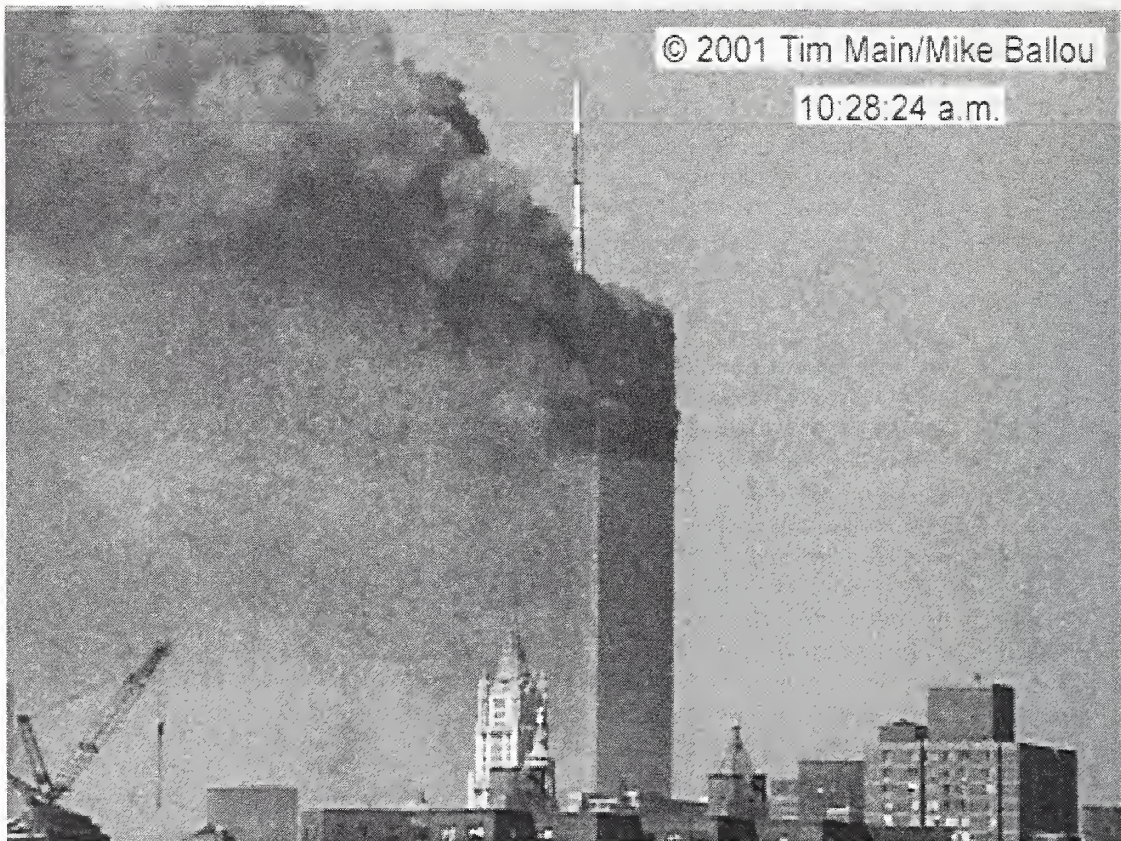
Roughly three seconds prior to the initiation of collapse at 10:28:22 a.m., the line of fire began to brighten noticeably, and intensely burning flames were coming from the 98th floor as the collapse began. As observed on the north face, flames were expelled from the east face by the pressure increase generated by the collapse. Figure 8-105 shows a frame taken from one of the long-range videos roughly two seconds after the collapse of WTC 1 began. The fire expelled from the 98th floor on the southern side of the east face is very bright. There was no apparent expulsion of fire from lower floors on this face. This supports the conclusion that the fire on the 98th floor was the largest fire present on this face at the time of collapse. In this same video a flame appeared much higher up on the south side of the east face roughly one and a half seconds after Figure 8-105 was recorded. It has not been possible to identify the origin of this expelled flame, but it does suggest that a fire was burning on a higher floor on this side of the tower.

Figure 8-105. This frame taken from a video recorded at 10:28:24 a.m. shows WTC 1 from the northeast.

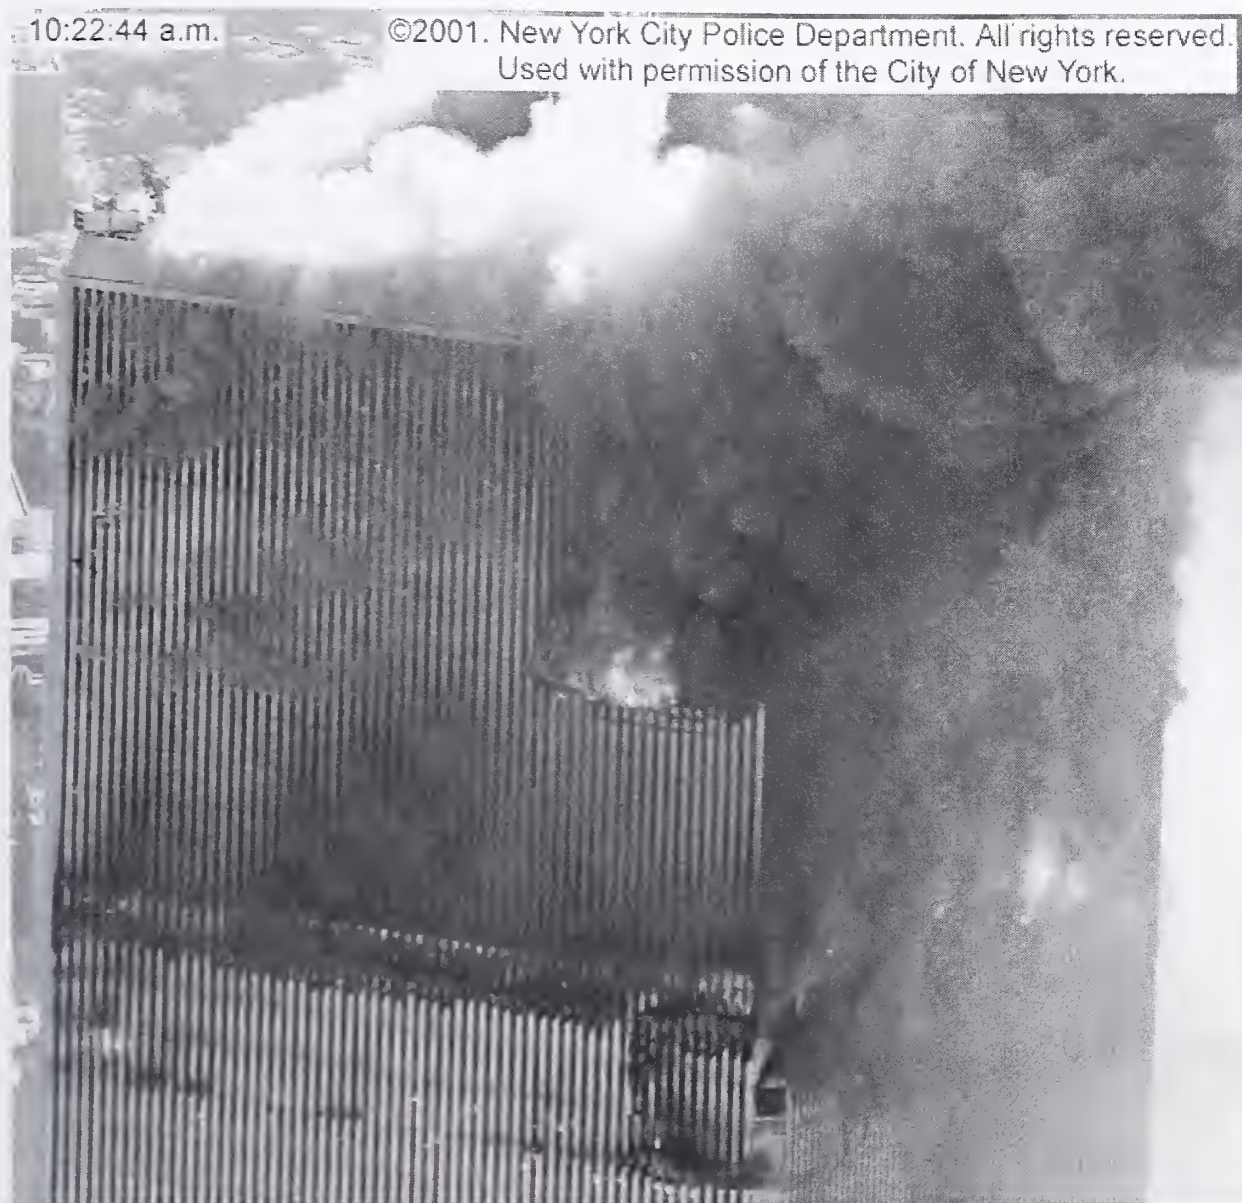
Figure 8-106 shows WTC 1 shot from the southwest at 10:22:44 a.m. The photographer was in a helicopter looking down on the tower. Individual floors are identifiable. Floor numbers can be assigned by noting that the floor with the missing aluminum panel on the southwest corner is the 96th floor. Fires are visible on both the south and west faces. Focusing on the south face, the most prominent feature is a flame jet emanating from an open window on the 98th floor on the east side. Flames are also coming out of nearby windows on this floor. Regions of fire are also visible on the 99th floor at locations starting on the west side of the face and reaching a position just to the east of the center of the face. From this angle, there are no flames evident on the 97th floor. Otherwise, the flame distribution is consistent with that described above.

Figure 8-106. This cropped photograph showing the south and west faces of WTC 1 was shot from a helicopter at 10:22:44 a.m. It has been enhanced by adjusting the intensity levels.

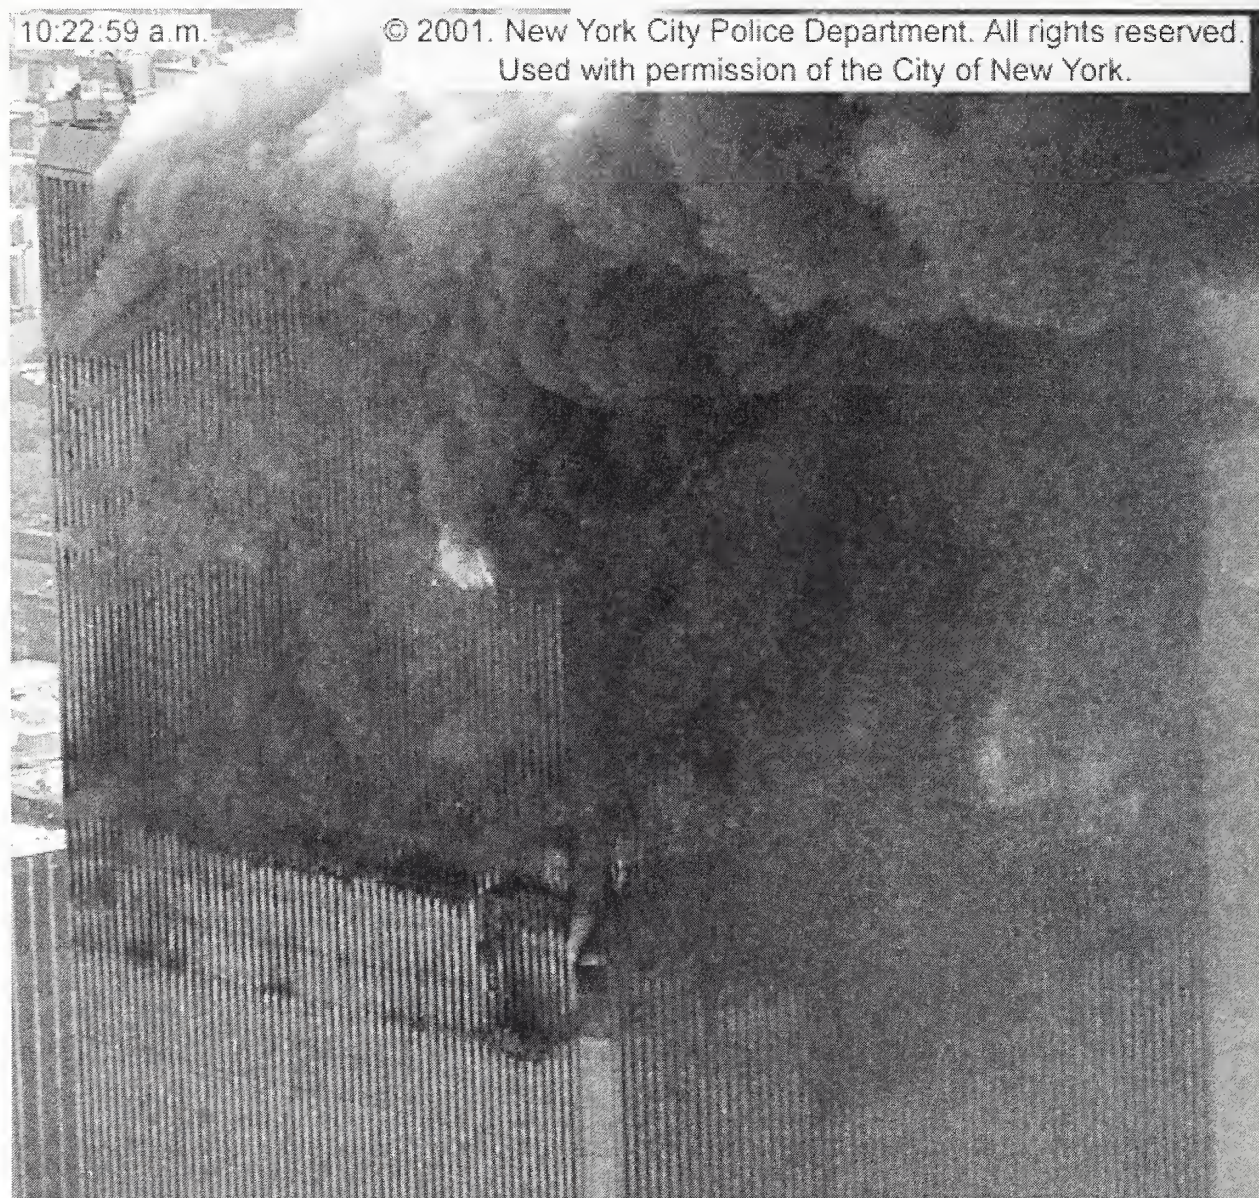
As the helicopter flew toward the south, the photographer continued to take pictures. Figure 8-107 shows a photograph taken 15 s later at 10:22:59 a.m. Since the helicopter was further south, this image has a more direct view of the south face than in Figure 8-106, and the view of the west face is from a more oblique angle. The fire distributions on both faces look quite different in the two photographs. This demonstrates the strong effects that the angle from which an image is taken can have on fire observations.

Figure 8-107. This cropped photograph showing the south and west faces of WTC 1 was shot from a helicopter at 10:22:59 a.m. It has been enhanced by adjusting the intensity levels.

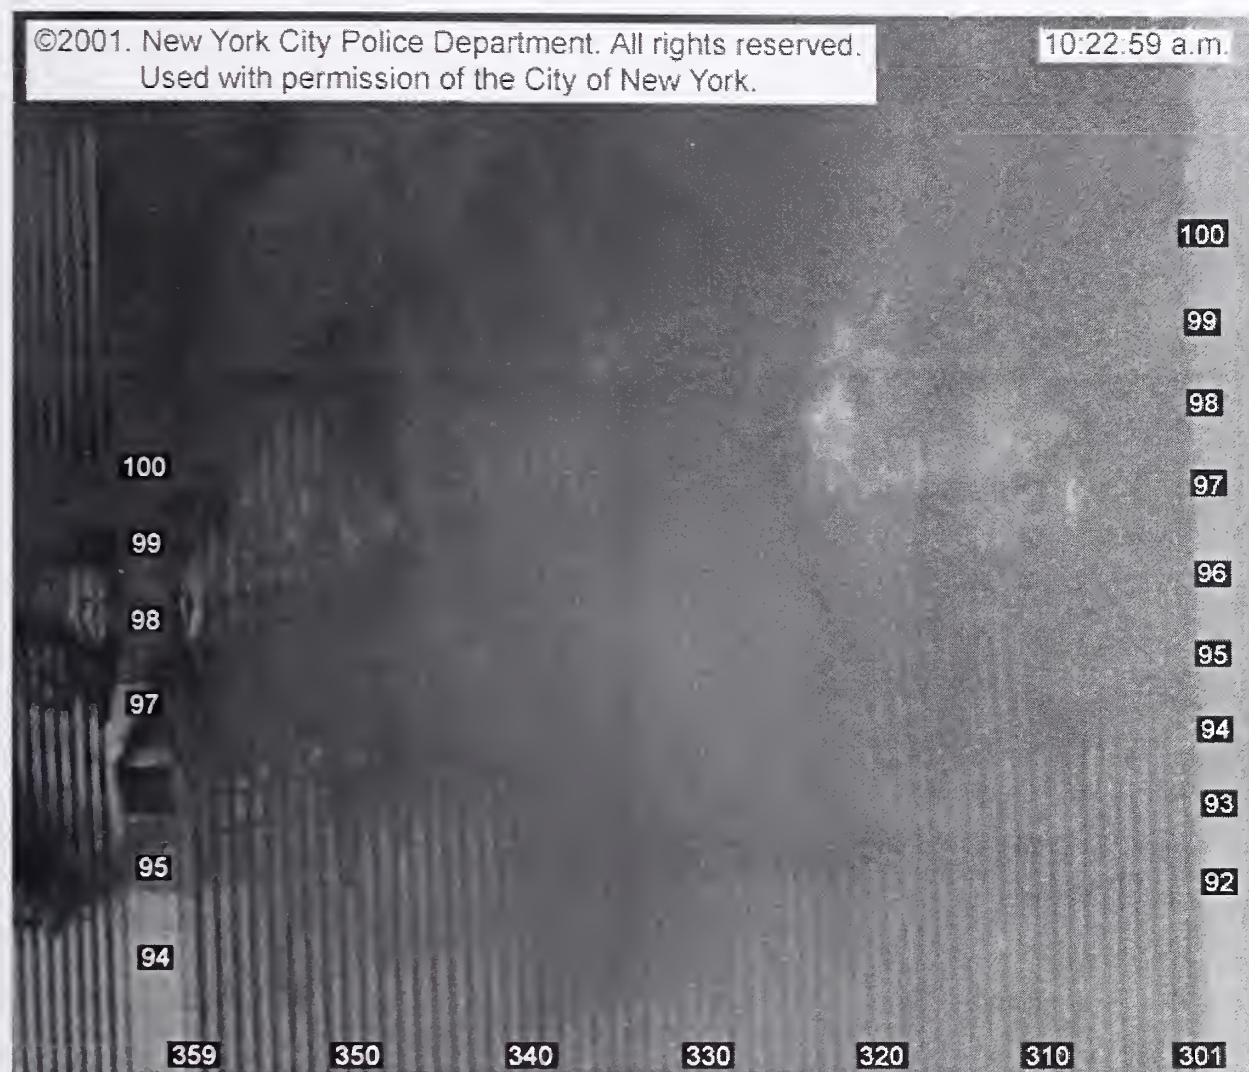
An important observation is readily apparent in Figure 8-108. Many of the columns on the south face in the vicinity of the 95th floor to 98th floors were bowed inward at this time. The easiest way to identify this bowing is to start lower down on the building and use your eyes to follow a particular column upward. The bowing appears as a curvature in the column. The bowing is most apparent on the eastern side of the face. It may be present on the western side as well, but it is more difficult to identify because of angular effects along with the blackening of the column covers on the western side of the face. Recall

that this blackening occurred as a result of the heavy smoke released on this side of the face by earlier fires on the 95th and 96th floors. The degree of column bowing is analyzed in the Investigation report dealing with the structural steel (NIST NCSTAR 1-3C) and compared with building response calculations in NIST NCSTAR 1-6.

Figure 8-108 shows that there were extensive fires on the south face of WTC 1 at 10:23 a.m. There is visual evidence for the presence of active fires on the 92nd floor upward through at least the 101st floor. Consistent with conclusions based on long-range images, the most intense fire is on the east side of the 98th floor. Flames that appear to be at least two stories in height are coming from windows 98-308 to 98-322. There are also large fires visible on the east side of the 97th floor and the west side of the

99th floor. On both floors the flames cover roughly half the width of the tower. In this photograph the flames on these floors do not appear to extend from the open windows. In reviewing the videos, it is clear that flames on both floors occasionally formed large external flares around this time. In fact, such a flare is visible coming from near window 97-308 in another photograph (not shown) taken from the helicopter at 10:22:50 a.m.

Figure 8-108. This photograph showing the south face of WTC 1 is a blowup of a portion of Figure 8-107. It was shot from a helicopter at 10:22:59 a.m. It has been enhanced by adjusting the intensity levels, and column and floor numbers have been added.

It is interesting that the fires on the 97th and 98th floors do not appear to have spread to the east end of the face. The last window with fire on the 97th floor appears to be window 97-308. A check of the floor plan layout in Figure B-6 shows that there was a room in the southeast corner of this floor with walls at columns 97-256 and 97-308. Recall that the fire spreading south on the east face of this floor did not appear to have reached the south edge at this time. These observations suggest that the walls of this room were acting as a fire barrier. A similar room was present and acting as a fire barrier on the 98th floor (see Figure B-7).

Glowing areas from internal fires near the eastern edge of the south face are visible on the 94th, 95th, and 96th floors. Recall that the presence of relatively small fires had been observed in this area of the 94th floor prior to the collapse of WTC 2. The fires on the 96th floor had been more intense earlier, as they were observed in long-range shots of the south face (e.g., see Figure 8–87).

Small flames are also visible on the 96th floor near the western edge of the building. This area began burning around 9:00 a.m. On the 97th floor just above, which began burning somewhat later, no flames are evident. The fact that the fires at the southwest corner of the 96th floor continued burning for an unusually long period may be an indication that there was a pile of debris in this location. This would be consistent with the removal of the cover aluminum panel from the southwest corner of the 96th floor during the aircraft impact and subsequent fireball.

Even though flames are visible on the 94th floor on both the eastern edge of the south face and near the southern edge of the west face, it appears as if much of the 94th floor along the south side of the building has not yet burned. This would suggest that the fire burning on the eastern side of the face reached this location by progressing down the east side of the floor. Recall that the fire on the east face had spread in this direction and had been observed near the south face.

Smoke appears to be coming from the 93rd floor from roughly window 93-318 to window 93-324. These windows were closed earlier. Even though flames are not visible at this location, this suggests that there may be a fire burning nearby. Smoke is also coming from multiple windows on the 92nd floor, and small spot fires are evident in several windows, including 92-312, 92-314, 92-333, and 92-334. This suggests that fires that were initially ignited on the east side of the tower shortly after the aircraft impact on the 92nd floor have also worked their way to the south face.

At some point between 10:24:20 a.m. and 10:24:55 a.m., heavy smoke began to pour from one or more south face windows on the 94th floor near the west edge. A burst of external flame occurred in the area at 10:25:10 a.m. In Figure 8–108 heavy flames and smoke can be seen coming from window 94-405 on the west face at 10:22:59 a.m. This window was located in a southwest corner room with walls at columns 94-405 and 94-353 (see Figure B-3). These observations indicate that the fire moving south along the west wall of the 94th floor entered this room and created flashover conditions around 10:23 a.m.

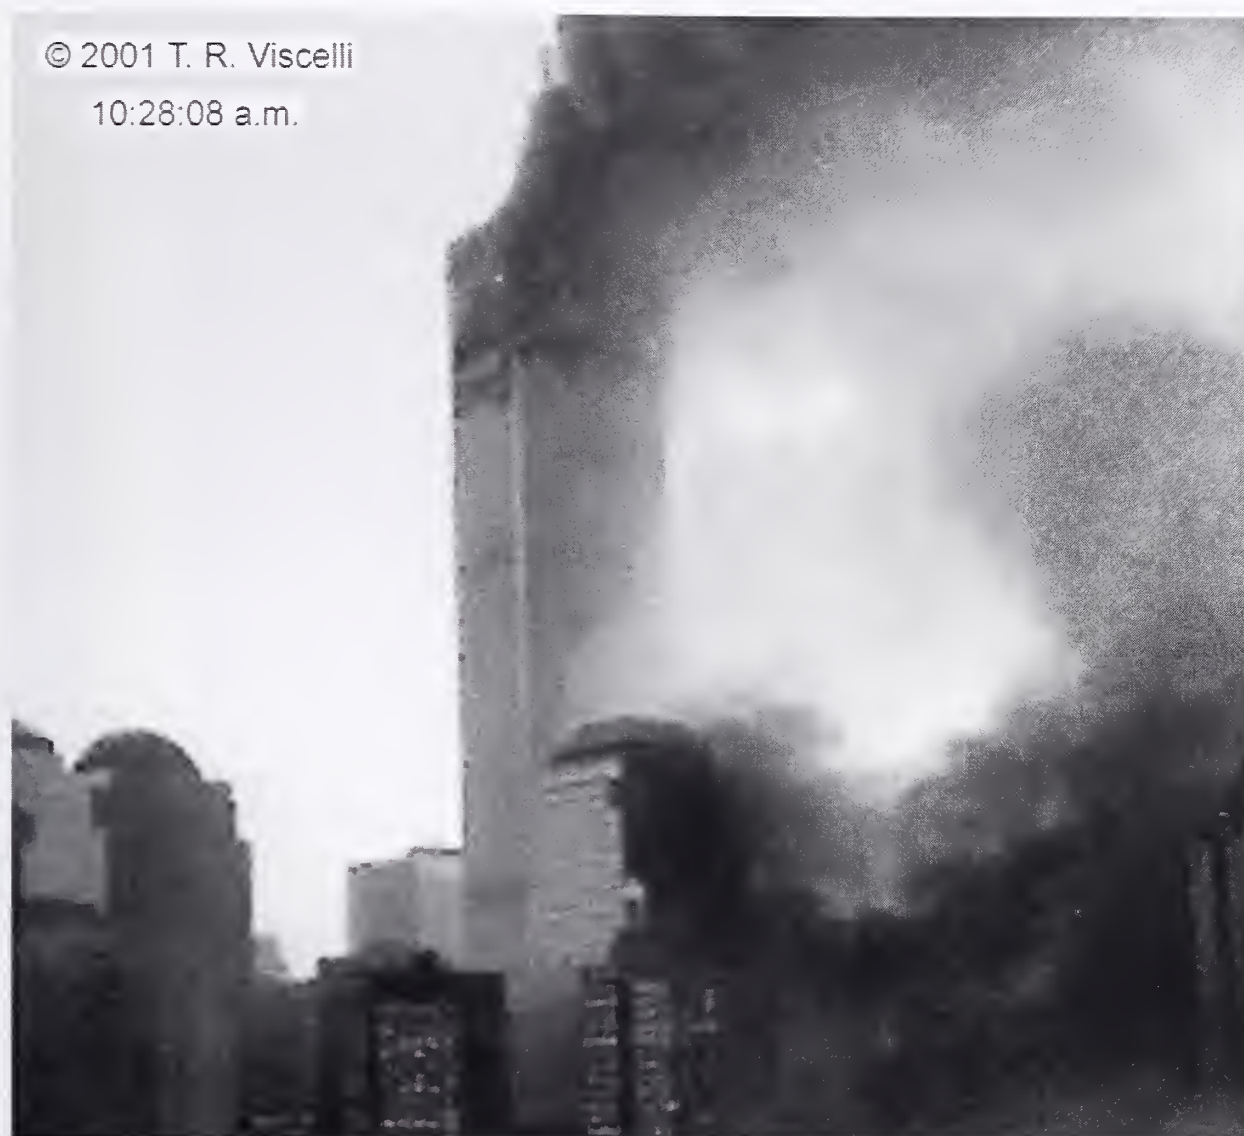
Figure 8–109 shows a long-distance photograph of WTC 1 that was shot at 10:28:08 a.m., i.e., 14 s prior to collapse. Even at this distance the intense fires burning on the east side of the south face on the 98th and 99th floors are readily apparent.

Figure 8-109. This cropped photograph taken from the south southwest shows WTC 1 at 10:28:08 a.m.

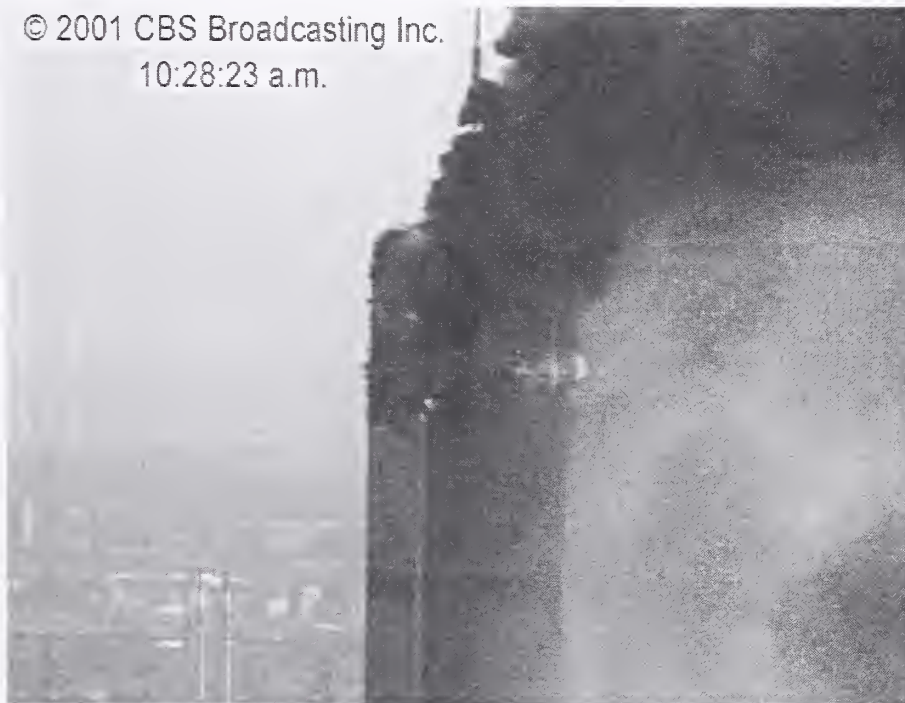
At 10:28:22 a.m. WTC 1 began to collapse. Unfortunately, the long-distance helicopter video is not particularly clear at this time. Even so, it is possible to see a large amount of flame being pushed from the tower on the south face by the pressure increase due to the collapse. The expelled fire appears to come from three separate locations on the south face. The first is from the vicinity of the intense fire burning on the east sides of the 98th and 99th floors. The second is from the fire burning on the western edge of the 94th floor. The location of the third area was more difficult to identify. It appears to come from the center of the eastern half of the face from near the 94th floor. It created a huge flame that at first was driven downward. So much fuel and heat were pushed out of the tower that a fireball formed and began to rise. The fireball burned out nearly 4 s after the collapse began.

Figure 8-110. This image showing the south face of WTC 1 was taken from a video shot from a news helicopter at 10:28:23 a.m. The intensity levels of the image have been adjusted. Two areas showing flames that were pushed out of the tower as it started to collapse are highlighted.

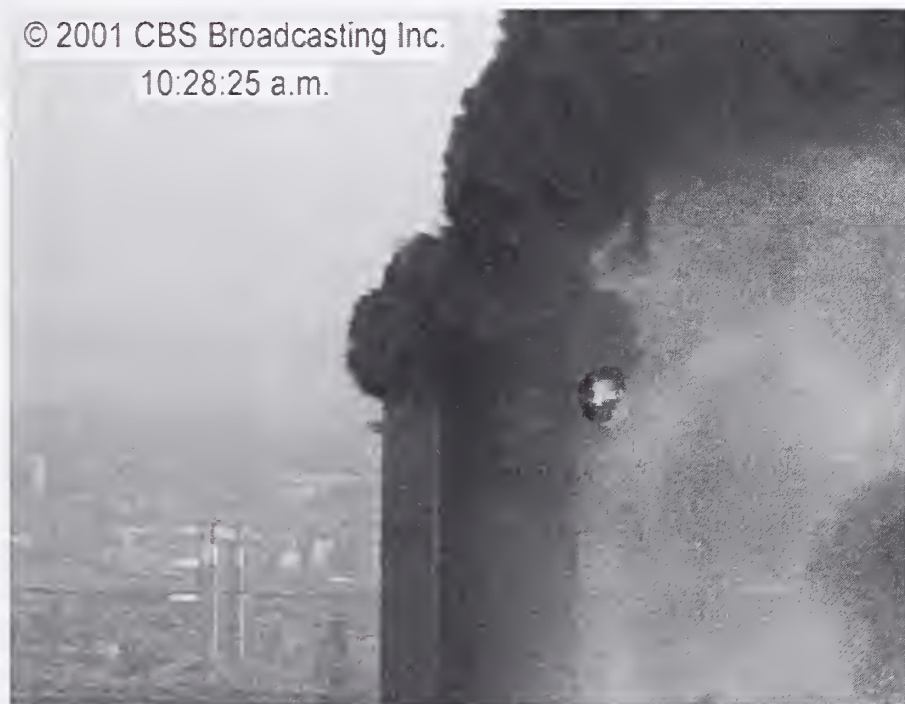
Figure 8-111. This image showing the south face of WTC 1 was taken from a video shot from a news helicopter at 10:28:25 a.m. The intensity levels of the image have been adjusted. An area showing a fireball generated by fire pushed from the tower by the collapse is highlighted.

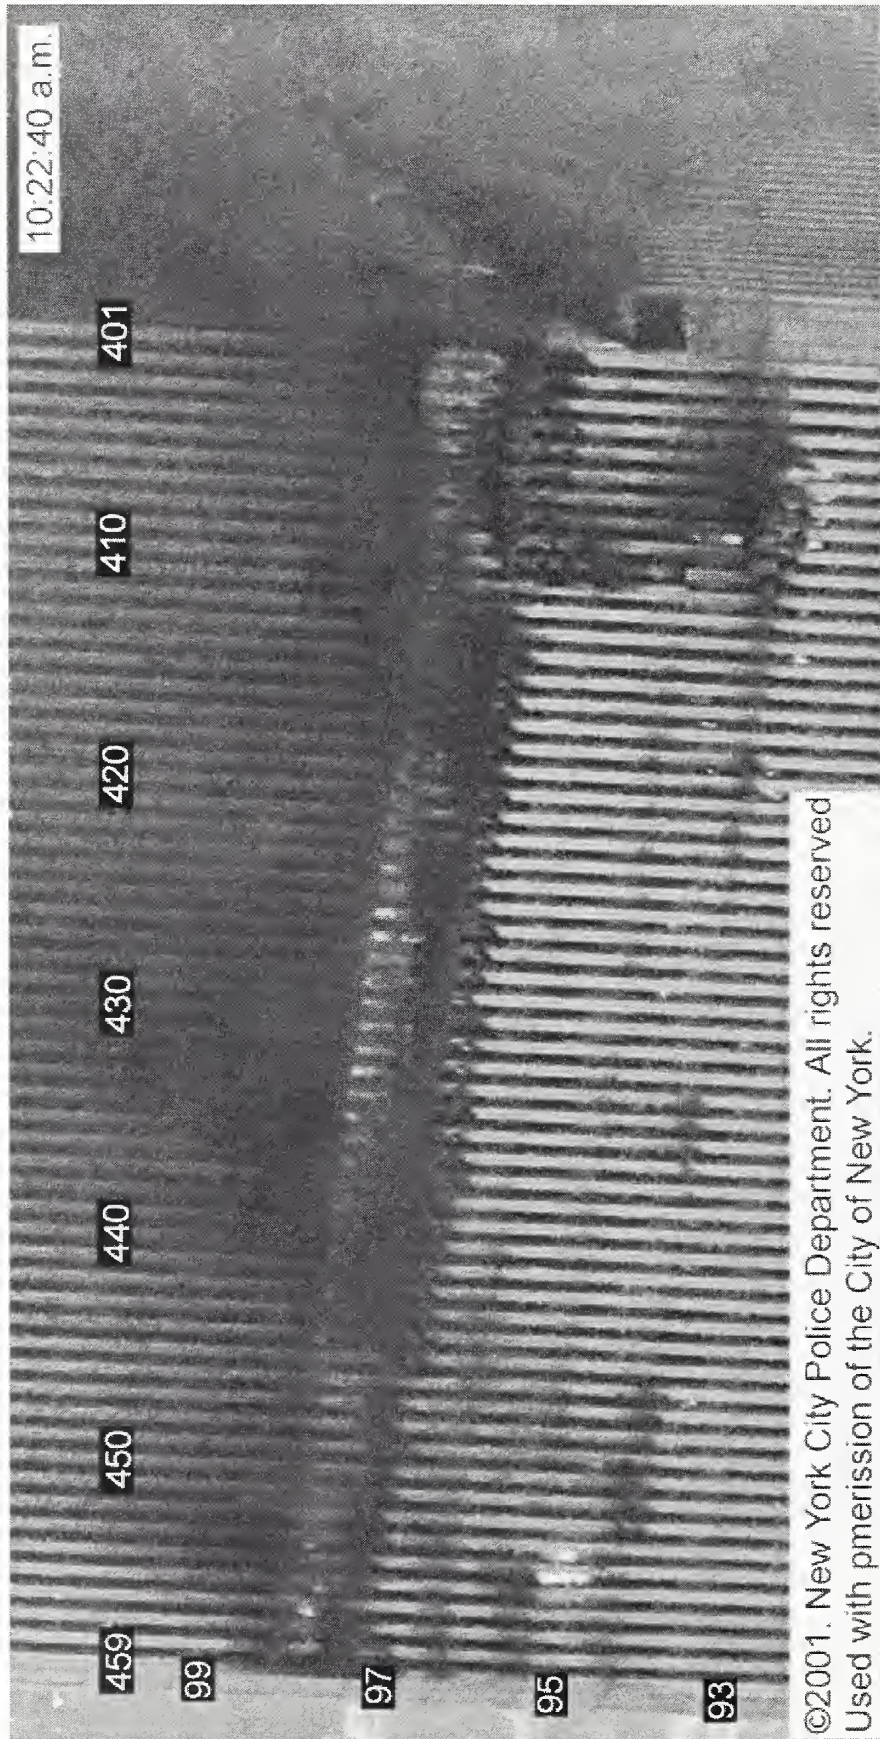
On the 94th floor fires can be seen at many locations between windows 94-405 and 94-448. Most of the fires are burning at isolated locations near the floor. The only window where flames are protruding out is 94-405. The presence of carets on nearby column covers is consistent with the intense fire seen earlier at windows 94-407 and 94-408. The smoke marks at the tops of the column covers indicate that at many locations only light smoke or no smoke had passed through the open windows. This agrees with earlier observations that the fires burning on the west side of the 94th floor were relatively gentle at most locations. In Figure 8–112 windows 94-438 to 94-441 appear to be open, and flames are visible in windows 94-438 to 94-440. These windows were clearly intact at 9:47:34 a.m. in Figure 8–72. The floor plan layout in Figure B-3 indicates that these four windows were located in a room with walls at columns 94-438 and 94-441. Fire had clearly spread into this room since 9:48 a.m. Many other windows on this floor that had intact glass at the earlier time are also open in Figure 8–112.

Figure 8-112. This cropped photograph was shot from a helicopter at 10:22:40 a.m. and shows the west face of WTC 1 from above. The image has been enhanced by adjusting the intensity levels, and column and floor numbers have been added.

Fires are visible on the 95th floor over most of the length of the west face. At most locations the fires look similar to those on the 94th floor, appearing to burn with low intensities near the floor. Exceptions are the most intense flames located in the room having walls at columns 95-452 and 95-456 (see Figure B-4) and the fire in windows 95-408 to 95-411. The fire on the north side has already been described, while the fire on the south side is located next to a room with walls at columns 95-404 and 95-408. Over most of this floor there are no smoke marks on the column covers despite the wide spread fires. This observation most likely means that the smoke from fires on this side of the 95th floor vented within the building elsewhere.

From the angle from which Figure 8-112 was taken the internal fires on the 98th floor are only visible near the center of the floor and at a few locations on either end. This fire has clearly died down considerably since Figure 8-92 was taken at 10:18:01 a.m. Carets are visible at the tops of the column covers near the two ends, but very little marking is evident elsewhere. This suggests that the only places flames came out of windows were from fires burning inside the corner rooms (see Figure B-7). Consistent with earlier observations, the absence of column cover marks elsewhere indicates that neither fire nor smoke flowed from most 98th floor windows on the west face where fire was present.

There is no indication of fire on the 96th or 97th floors on the west face. Both of these floors were on fire much earlier and have apparently completely burned out. It is worthwhile to point out once again the difference in column cover markings between the two floors. Heavy smoke and fire came from most of the windows on the 97th floor, as revealed by the numerous carets on the covers. On the other hand, the 96th floor seemed to burn much more like the fires seen on the 94th and 95th floors, i.e., gently with little smoke and fire coming from windows.

There are no indications of fire or open windows on the west side of the 92nd floor or 93rd floor. Apparently fires burning elsewhere on these floors had not yet reached this face.

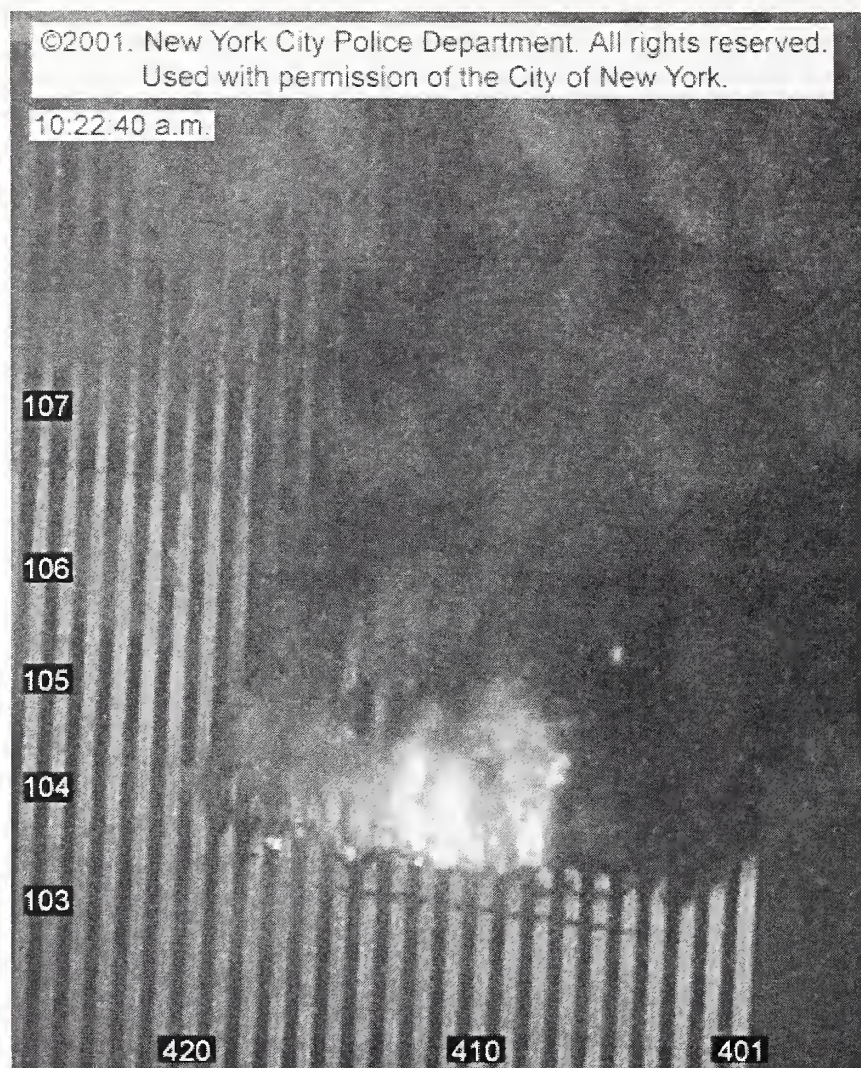
An image of the fires on the 104th floor at 10:22:40 a.m. is shown in Figure 8-113. It was cropped from the same photograph as Figure 8-112. It shows that after first appearing twenty minutes earlier, this fire continues to burn very intensely with long flames extending out of the windows. Visible flames and column cover smoke marks indicate this fire has burned from window 104-403 to window 104-418. Despite the intensity of the fire, it has not spread significantly since its initial growth period, as indicated by comparison with earlier photographs.

Figure 8-113. This cropped photograph shows a view of the west face of WTC 1 shot looking down from a helicopter at 10:22:40 a.m. The image has been enhanced by adjusting the intensity levels, and column and floor numbers have been added.

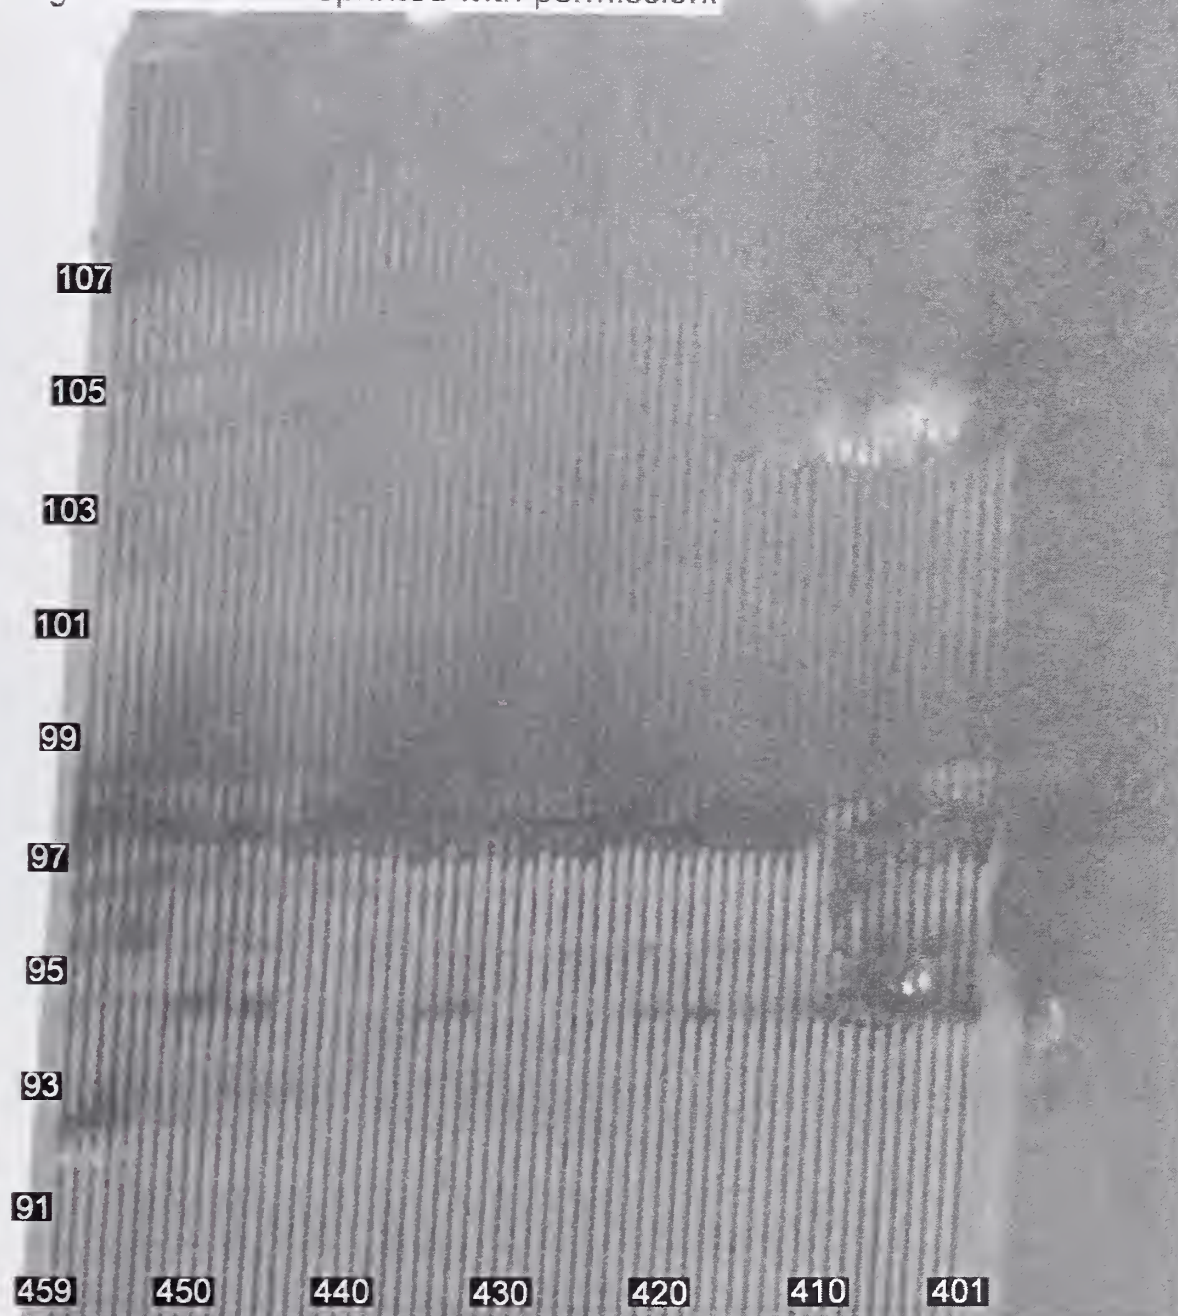
Close-up imagery of the west face over the next several minutes was very limited. Figure 8-114 shows an image of the face recorded at 10:26:54 a.m. that provides sufficient resolution to resolve windows and floors. Fires are visible at several locations on the face. Some changes have taken place since Figure 8-112 was taken at 10:22:40 a.m. Fire has appeared in the two adjacent rooms nearest the northwest corner of the 92nd floor (see Figure B-1), which have walls at columns 92-452 and 92-455 and share an east wall that terminates at column 92-105. Flames are now present in windows 92-454 to 92-458. Videos shot from the northwest and southwest show that heavy smoke first appeared in this area at 10:25:21 a.m. As already discussed, a similar stream of smoke came from window 92-101 on the north face at 10:24:26 a.m. These observations indicate that flashover occurred in these rooms around this time.

Flames are also visible in Figure 8-114 on the 94th floor in windows 94-101 to 94-104 that were not visible in Figure 8-112. This is consistent with the conclusion (discussed above) that flashover occurred in the southwest corner room of this floor (see Figure B-3) around 10:23 a.m. Flames also extend a significant distance from open windows in this room on the south face.

In the earlier photograph (Figure 8-112) a bright flame was evident at window 95-408 on the 95th floor, but windows further to the south appeared to be closed. In Figure 8-114 bright fires can be seen in windows 95-404 and 95-405. This indicates that fire had entered the room along the west face having walls at columns 95-404 and 95-408 (see Figure B-4). Based on this photograph, the windows in the corner room with walls at columns 95-350 and 95-404 may still be closed.

The interior fire near the center of the 98th floor is still visible in Figure 8-114. Flames are also visible in the windows located in the room on the 95th floor that had walls at columns 95-452 and 95-456, but the flames appear to have died down somewhat since 10:22:40 a.m. The flames seen at other locations on the

94th and 95th floors in the earlier photograph are not apparent at the later time. This is not surprising since this photograph was shot from the ground, albeit at a large distance, and fires burning near the floors should not be visible.

Figure 8-114. This cropped photograph showing the west face of WTC 1 was taken at 10:26:54 a.m. The image has been enhanced by adjusting the intensity levels, and column and floor numbers have been added.
